Report No. **CG-D-01-99, III**

**Investigation of Fuel Oil/Lube Oil Spray Fires
On Board Vessels**

Volume III

Incident Databases

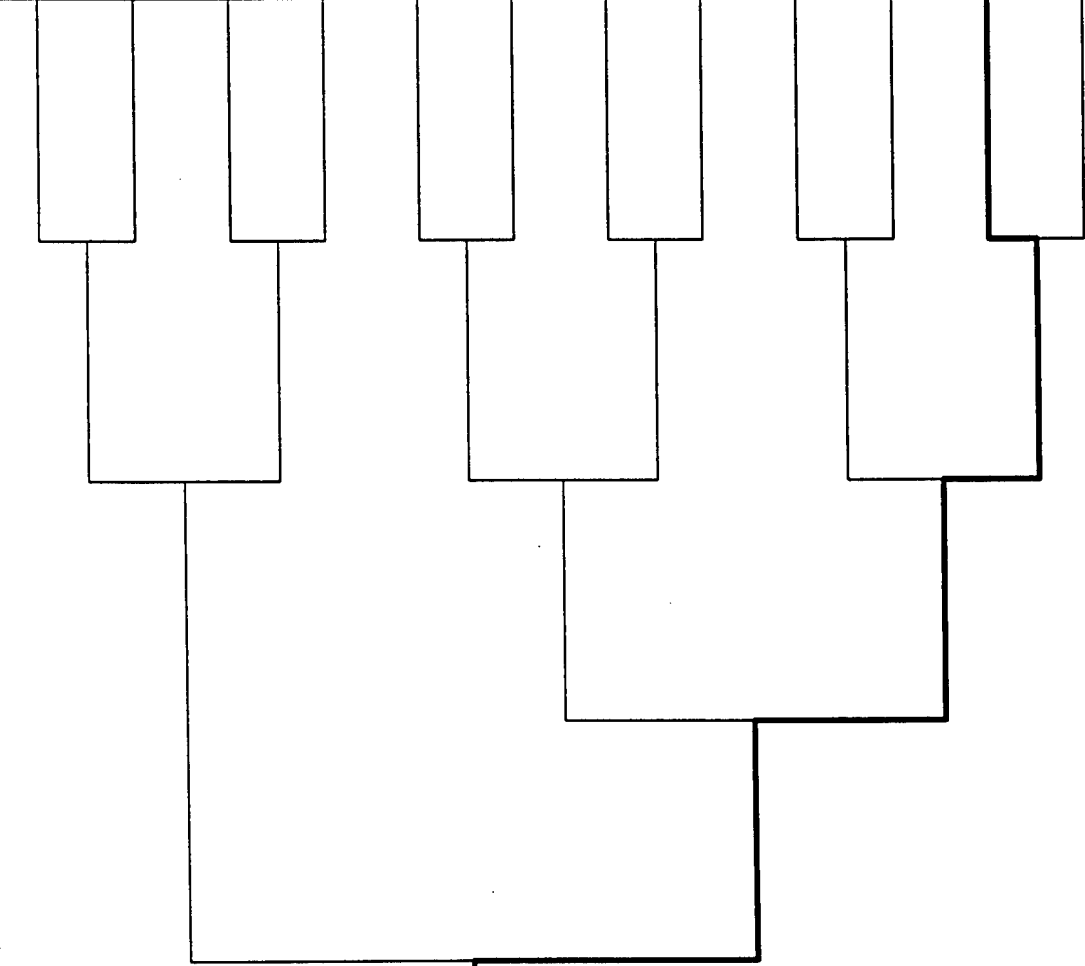
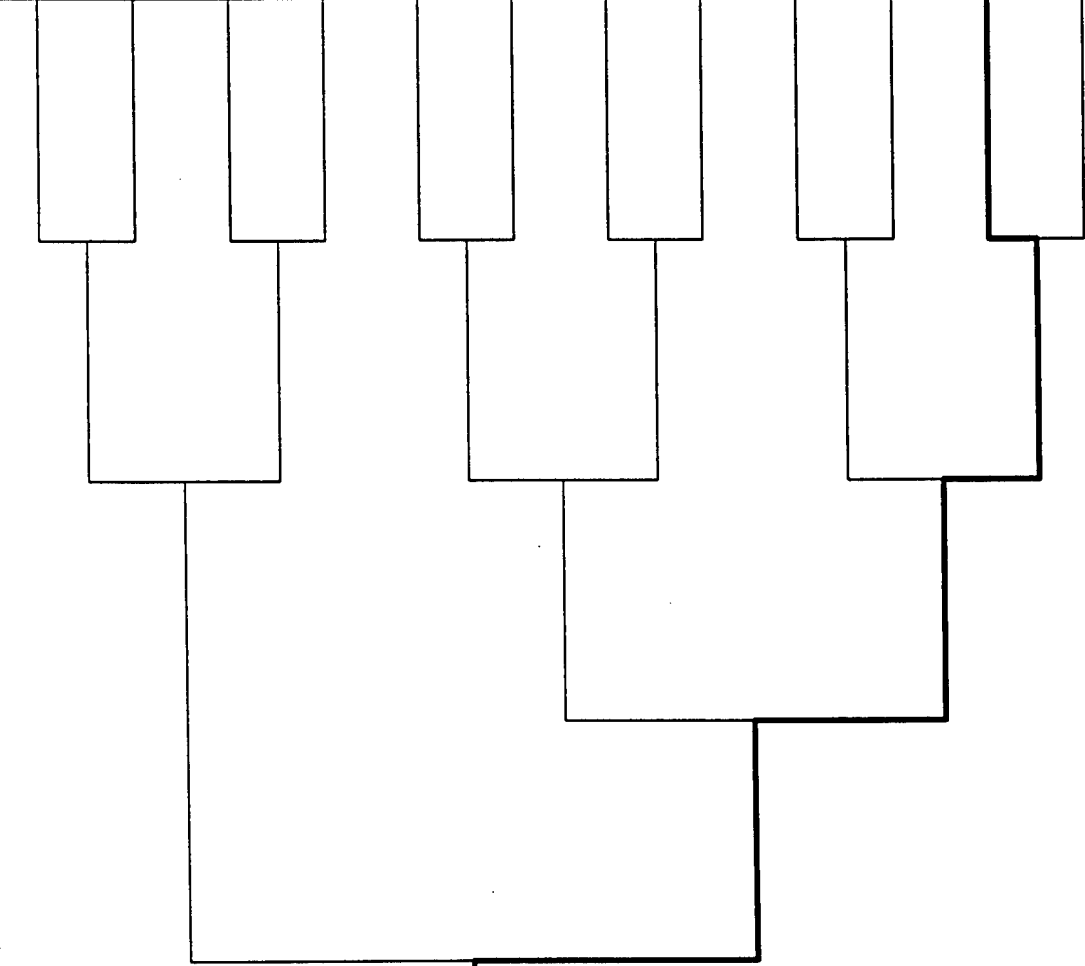
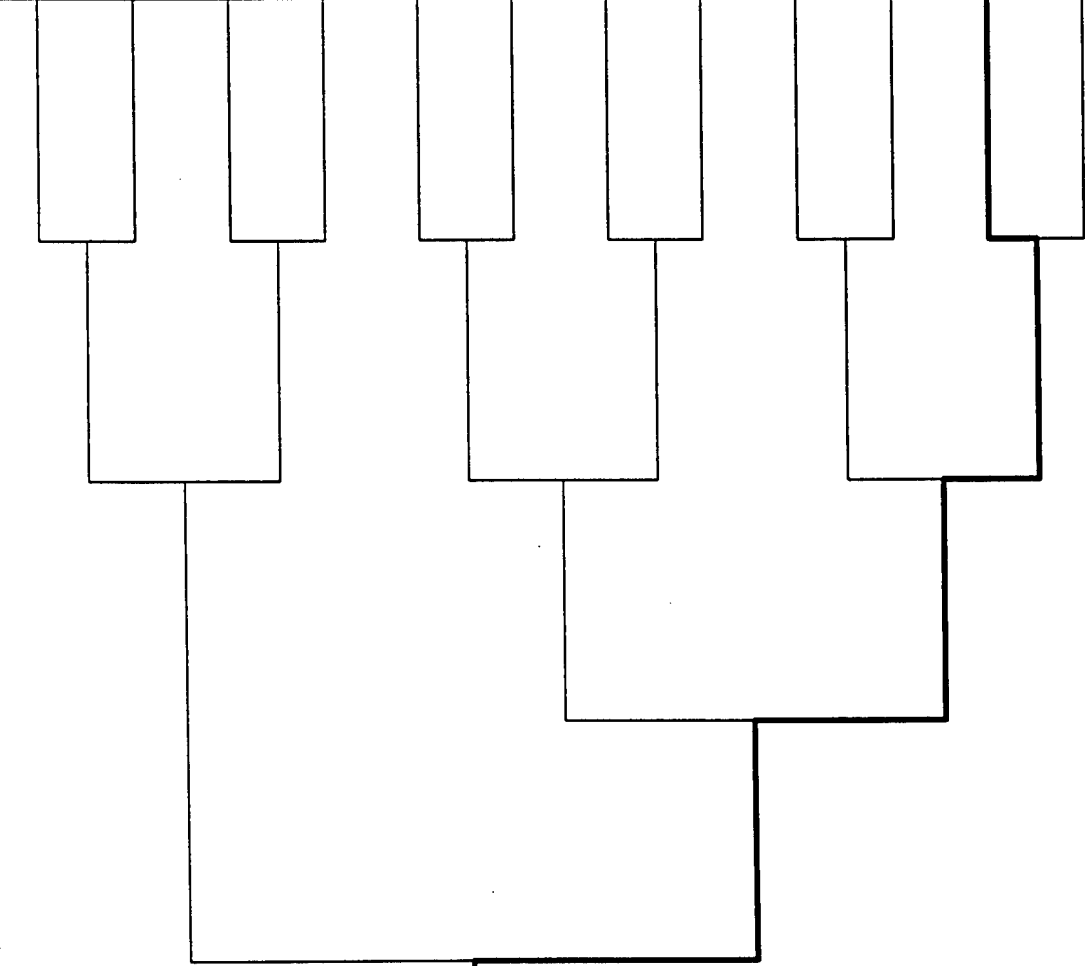
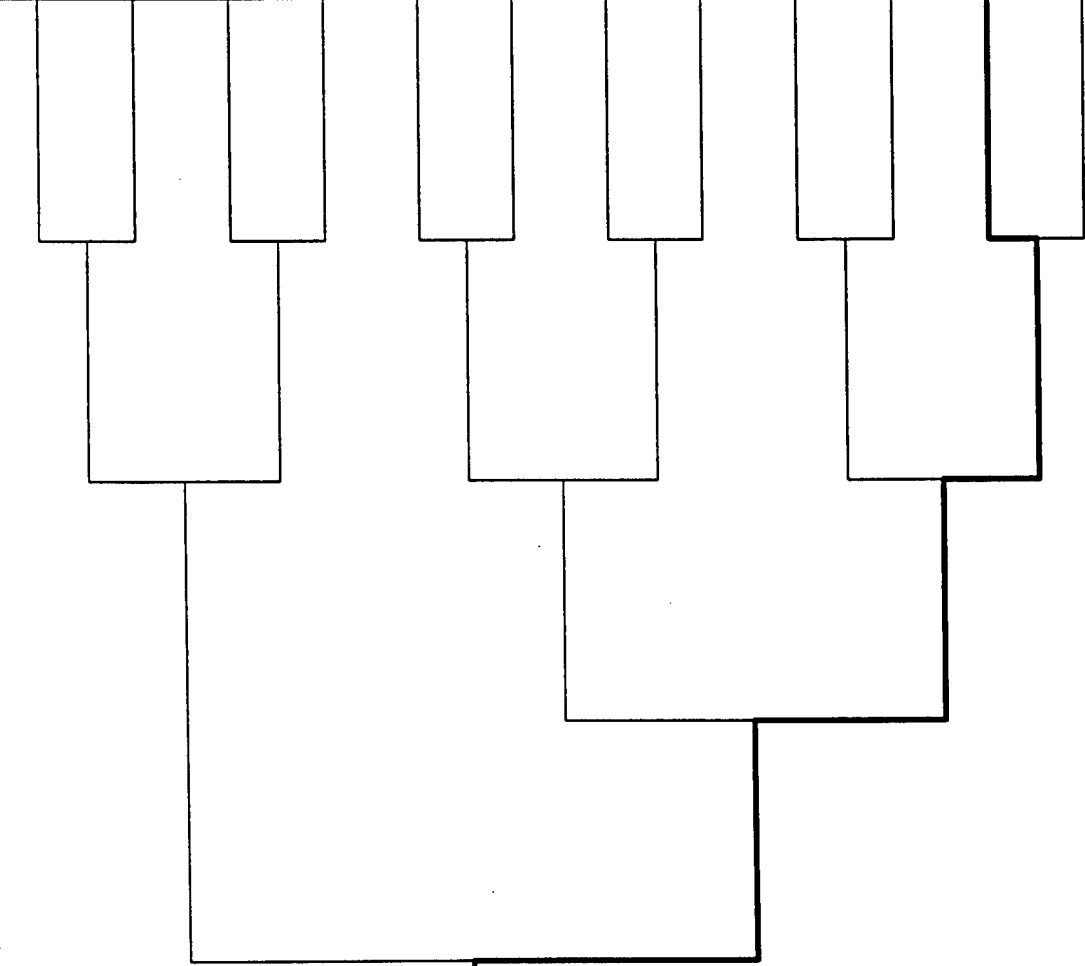
Release of pressurized flammable or combustible liquid	Prevent spray ignition	Prevent fire propagation to other hull compartments	Prevent loss of propulsion or steering	Prevent human casualty	Consequence
Event: LR30

Event Number: 7410060 (LR30)	Event Characterization	
	As Documented in the Event Report	As Inferred from the Event Report
System/Location	Not stated/engine room	
Cause	Not stated	Not inferred
Ignition Source	Not stated	Not inferred
Detection	Not stated	Not inferred
Release Isolation	Not stated	Not inferred
Fire Suppression	Not stated	Not inferred
Impact on Propulsion		Loss of propulsion (the vessel sank)
Impact on Steering		Loss of steering (the vessel sank)
Human Casualty	No fatalities	
Corrective Action to Prevent Recurrence	No preventive action mentioned

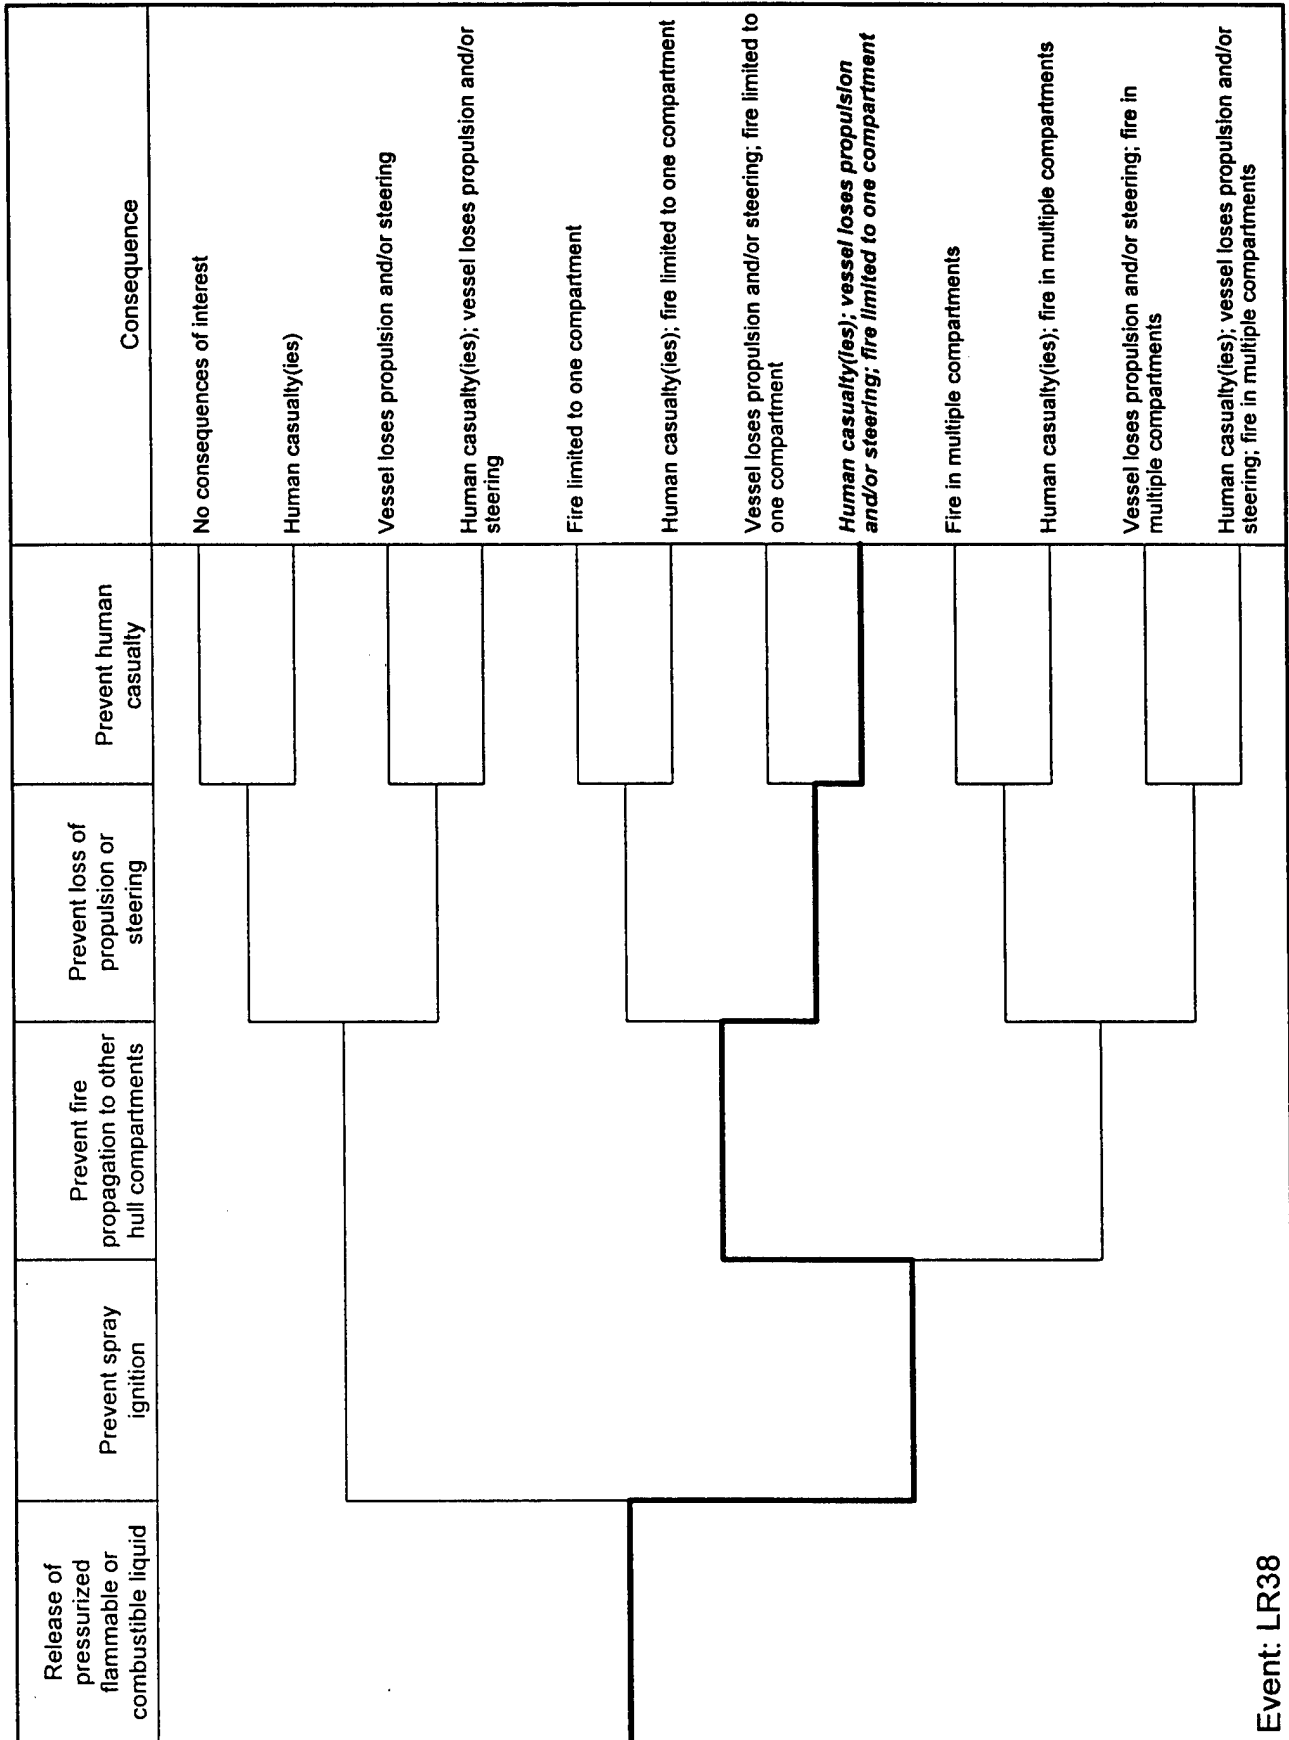
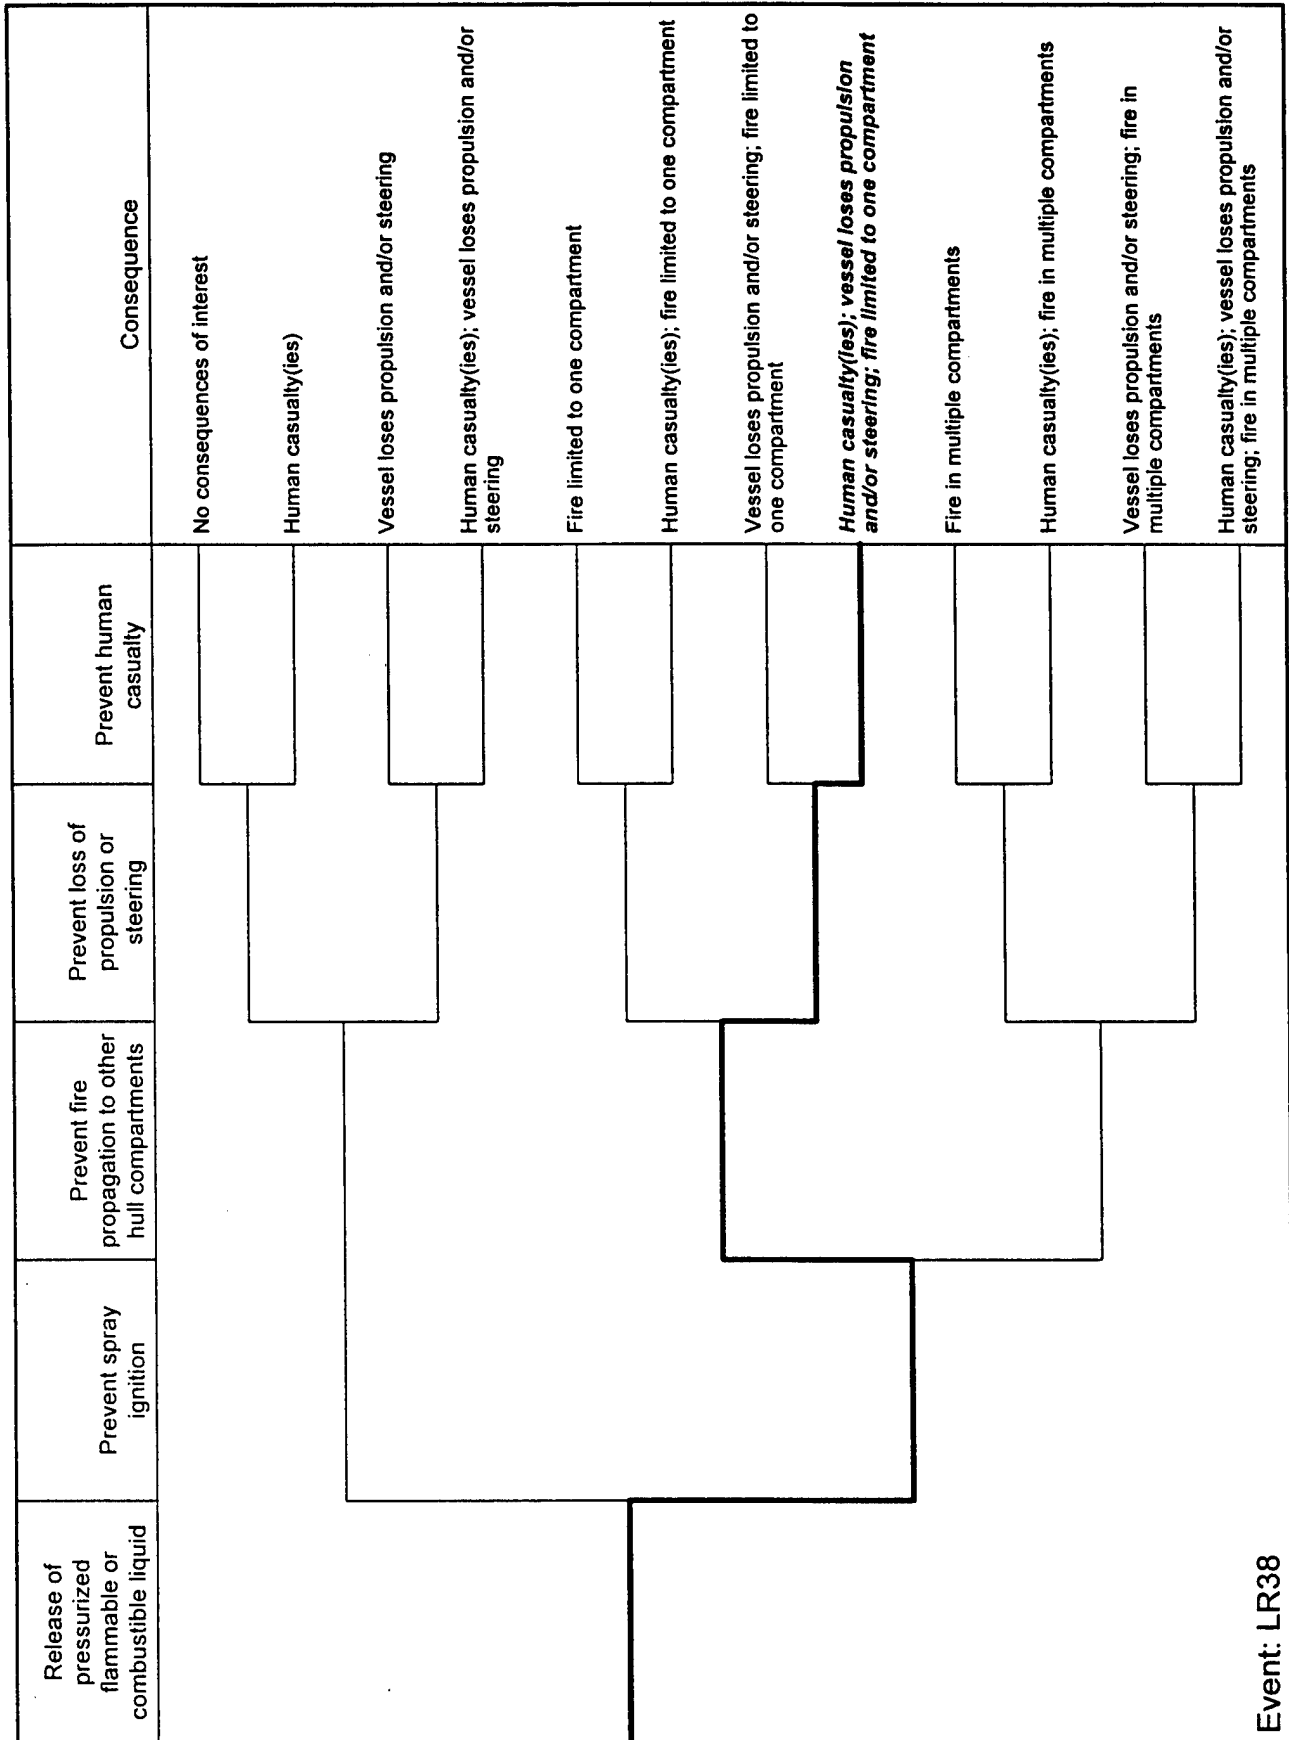
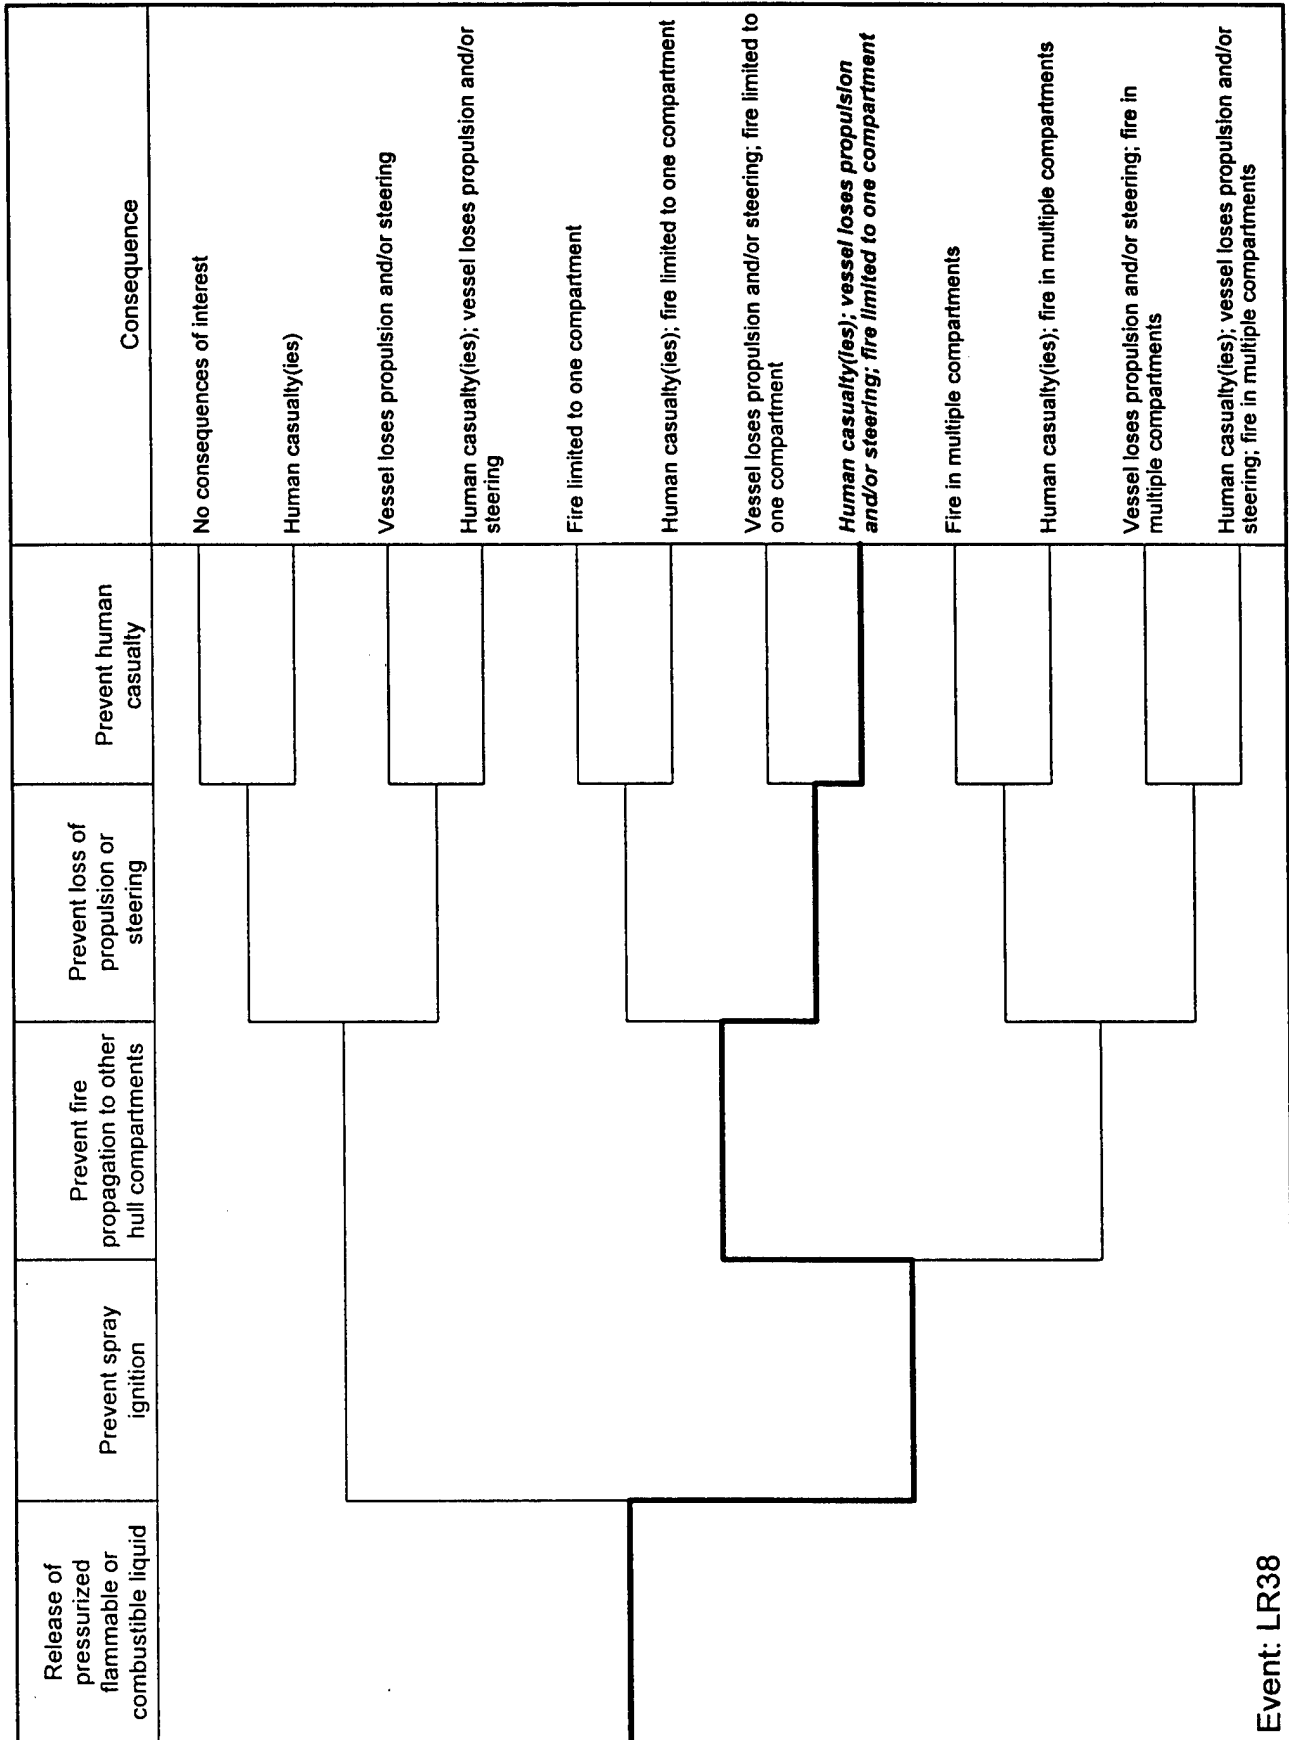
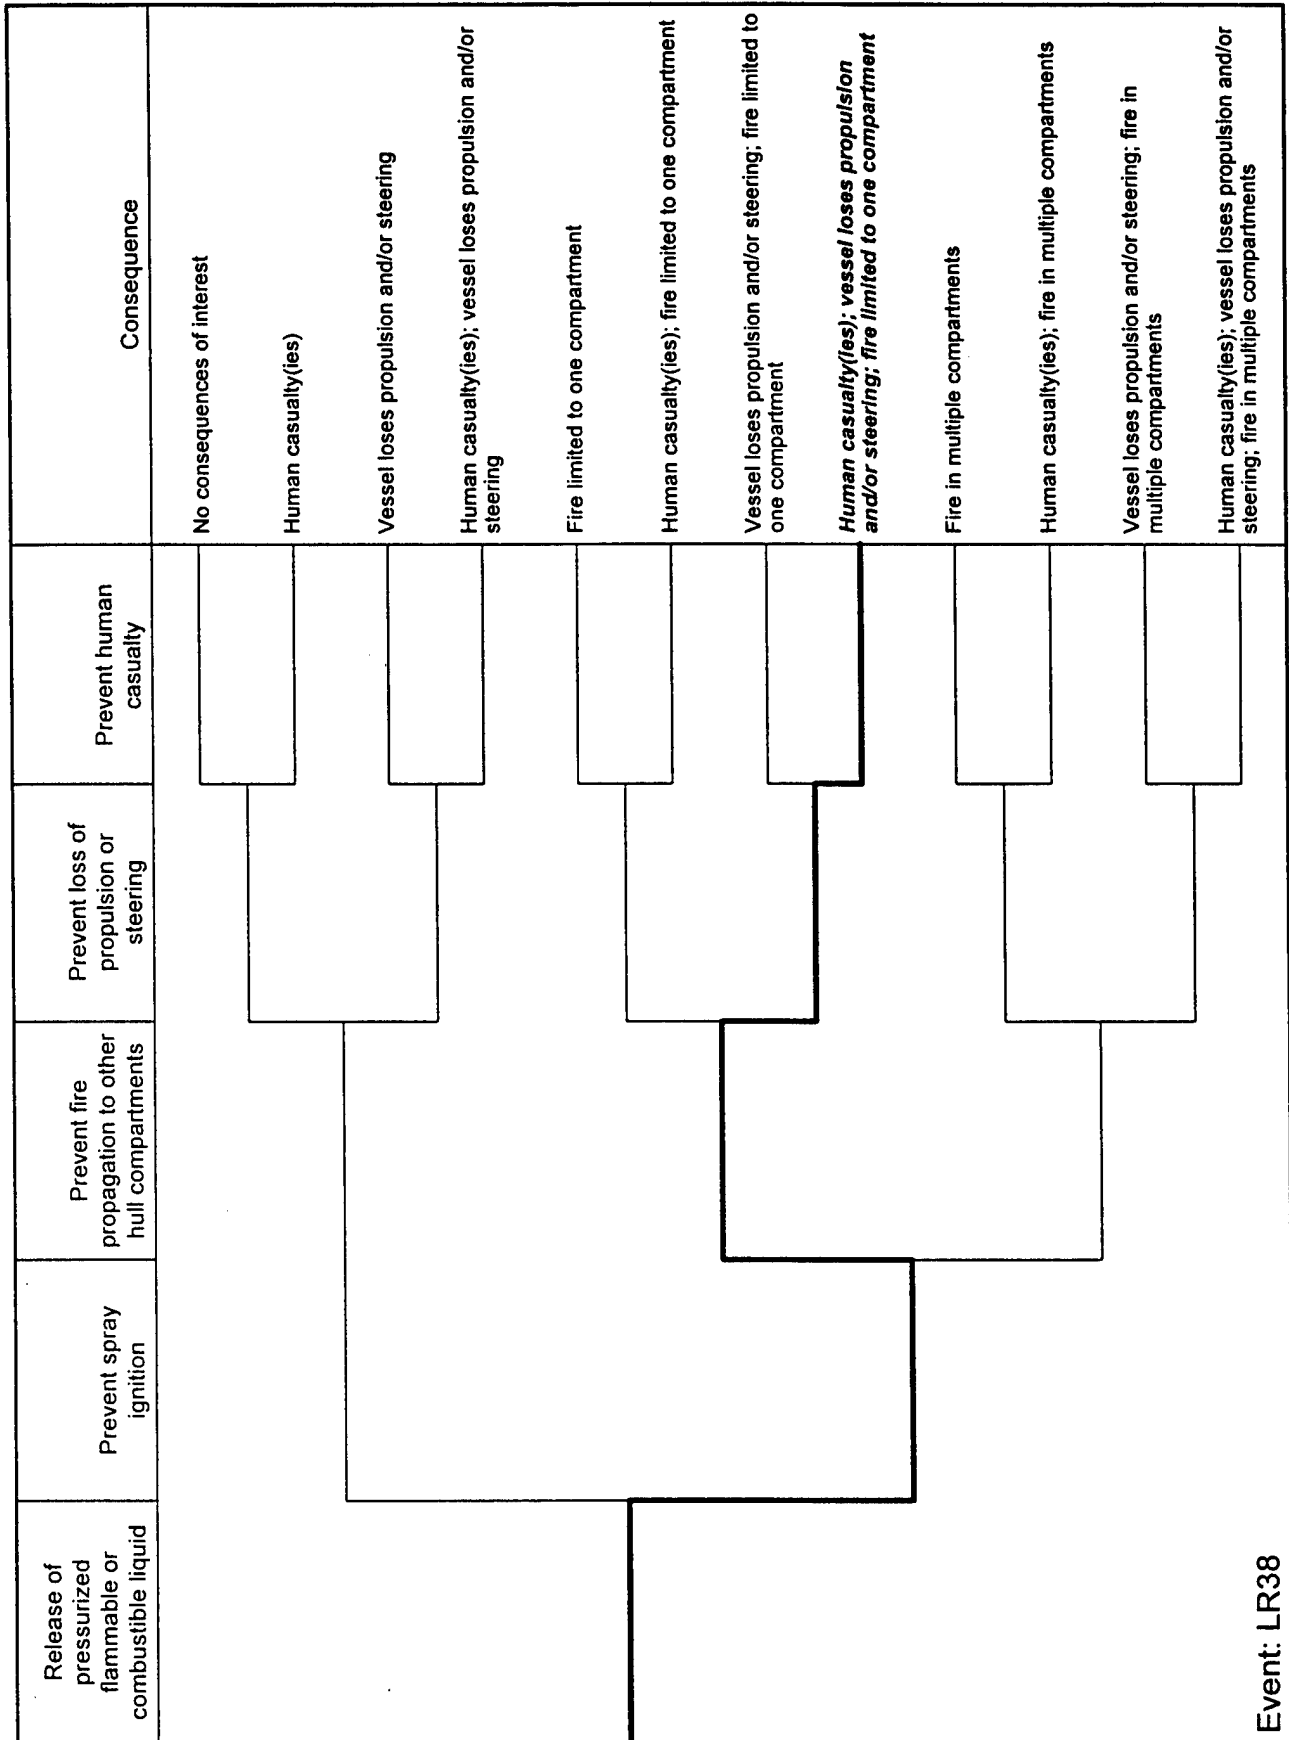
Release of pressurized flammable or combustible liquid	Prevent spray ignition	Prevent fire propagation to other hull compartments	Prevent loss of propulsion or steering	Prevent human casualty	Consequence
Event: LR38

HIGH PRESSURE MAIN ENGINE FUEL PIPE FRACTURED, SPRAYING OIL ONTO HOT EXHAUST MANIFOLD. FIRE WAS EXTINGUISHED BY USING FITTED FOAM-SMOTHERING SYSTEM.

Event Number: 7826867 (LR38)	Event Characterization	
	As Documented in the Event Report	As Inferred from the Event Report
System/Location	Fuel oil/engine room	
Cause	A fuel pipe fractured	
Ignition Source	Not stated	Not inferred
Detection	Not stated	Not inferred
Release Isolation	Not stated	Not inferred
Fire Suppression	Not stated	Not inferred
Impact on Propulsion	Loss of propulsion (the vessel had to be towed)	
Impact on Steering		None
Human Casualty	One fatality	
Corrective Action to Prevent Recurrence	No preventive action mentioned – the vessel was repaired
